# Engineering geological modeling and stability assessment of the Niasar waterfall slope using advanced zonation techniques

Hasnain Haider<sup>1\*</sup>, Enayatallah Emami Meybodi<sup>2</sup>

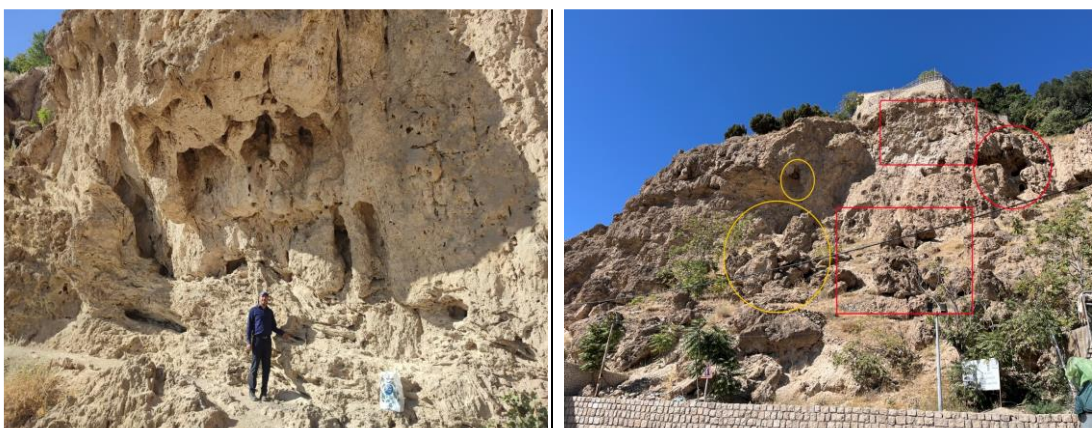
**Fig. 2.** The figure displays caves formed by the weathering and erosion of impurities and soft materials, with evidence of clay and sand presence observed.

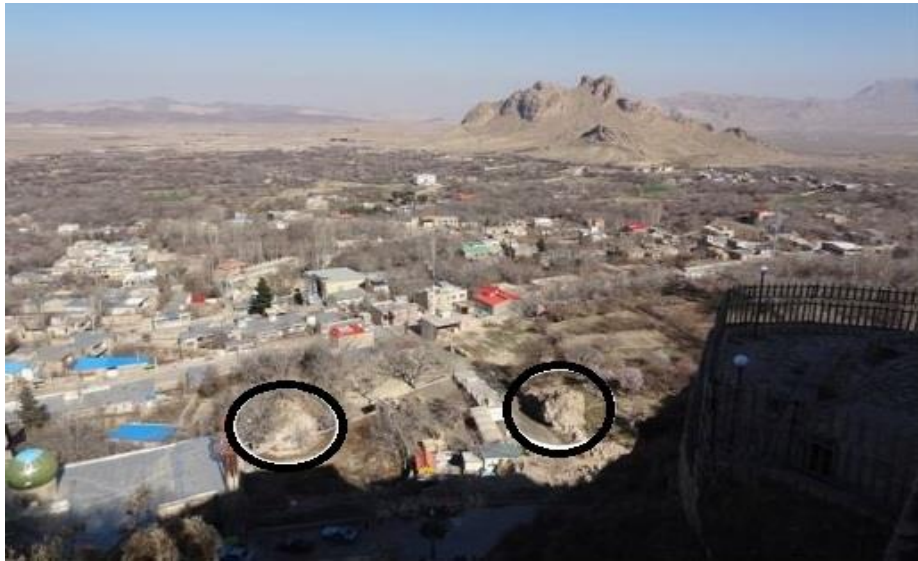
**Fig. 3.** Approximately 30 years ago, an earthquake caused these two massive stones to separate from the wall and fall into the inhabited area below.

Approximately thirty years ago, a moderate-magnitude seismic event triggered a significant rockfall on the Niasar slope. Two large rock blocks detached from the slope and descended into the populated area. While fortuitously no casualties were reported, the earthquake exacerbated existing geological conditions. Specifically, it widened a pre-existing tension crack, estimated to be 30 meters deep and 1 to 1.5 meters wide, located near the slope's crest. This event, along with the subsequent development of new fissures and voids within the slope's rock wall, heightened concerns among government and local authorities regarding the stability of this historical site and the safety of the Niasar village population. The incident underscored the urgent need for intervention to preserve the area for both tourism and local residents.
