# Engineering geological modeling and stability assessment of the Niasar waterfall slope using advanced zonation techniques

Hasnain Haider<sup>1\*</sup>, Enayatallah Emami Meybodi<sup>2</sup>

## ABSTRACT

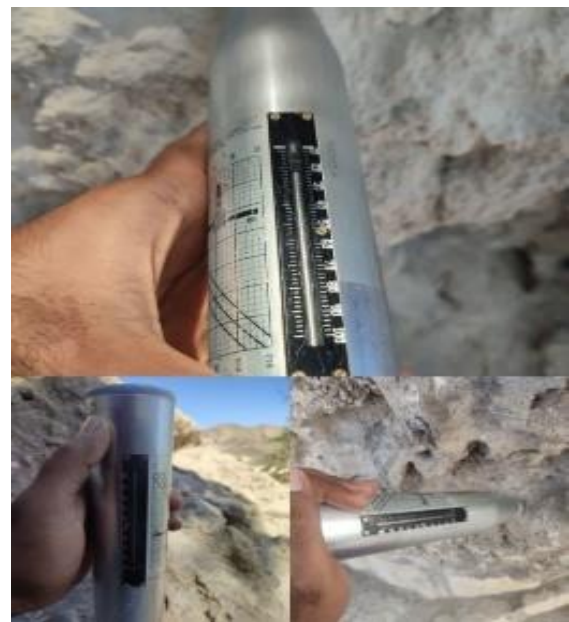
**Fig. 5.** Schmidt Hammer test

The rock strength was evaluated using a Schmidt hammer. Tests were performed at multiple locations around the waterfall, pavilion, and the staircase connecting them. Field observations indicated generally weak rock characteristics throughout most of the tested areas. This weakness is primarily attributed to the presence of marl and gypsum interspersed with limestone and travertine within the rock mass. Schmidt

hammer rebound values ranged from 10 to 15, indicating low rock strength at nearly all tested sites. Similar low values were recorded inside the cave, further confirming the overall rock weakness. These findings classify the rock in the study area as a weak rock type, likely due to its mineralogical composition.
