# Engineering geological modeling and stability assessment of the Niasar waterfall slope using advanced zonation techniques

Hasnain Haider<sup>1\*</sup>, Enayatallah Emami Meybodi<sup>2</sup>

Numerical modeling, micro and macro zoning, slope stabilization, engineering geology mapping, geotechnical assessment

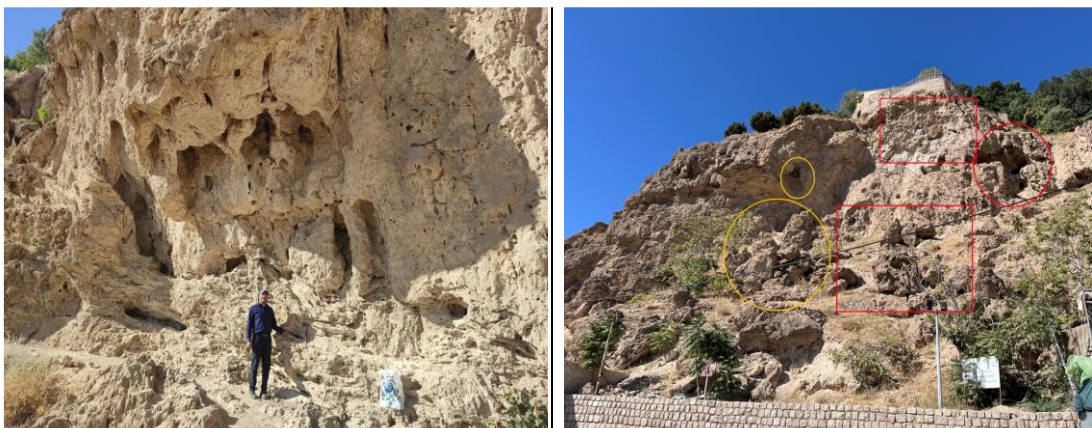
**Fig. 2.** The figure displays caves formed by the weathering and erosion of impurities and soft materials, with evidence of clay and sand presence observed.

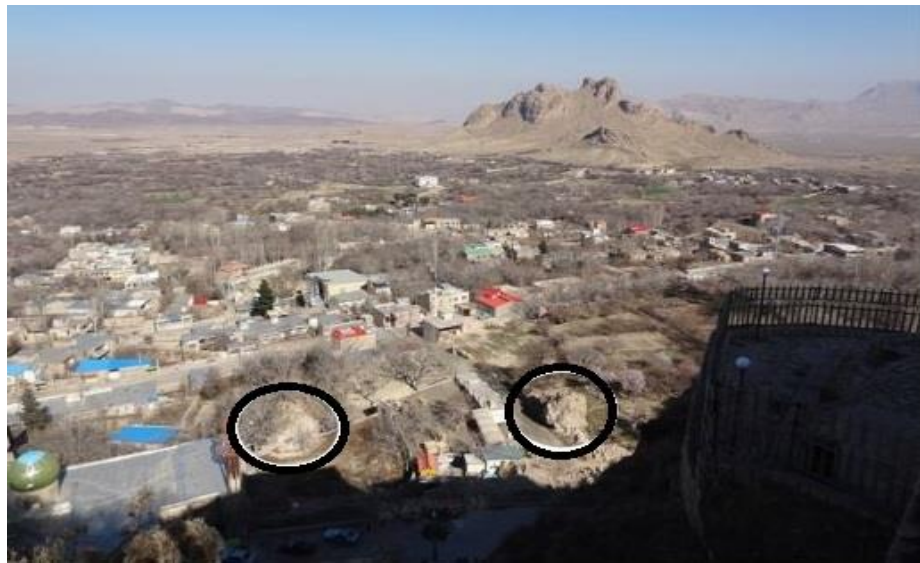
**Fig. 3.** Approximately 30 years ago, an earthquake caused these two massive stones to separate from the wall and fall into the inhabited area below.

Approximately thirty years ago, a moderate-magnitude seismic event triggered a significant rockfall on the Niasar slope. Two large rock blocks detached from the slope and descended into the populated area. While fortuitously no casualties were reported, the earthquake exacerbated existing geological conditions. Specifically, it widened a pre-existing tension crack, estimated to be 30 meters deep and 1 to 1.5 meters wide, located near the slope's crest. This event, along with the subsequent development of new fissures and voids within the slope's rock wall, heightened concerns among government and local authorities regarding the stability of this historical site and the safety of the Niasar village population. The incident underscored the urgent need for intervention to preserve the area for both tourism and local residents.

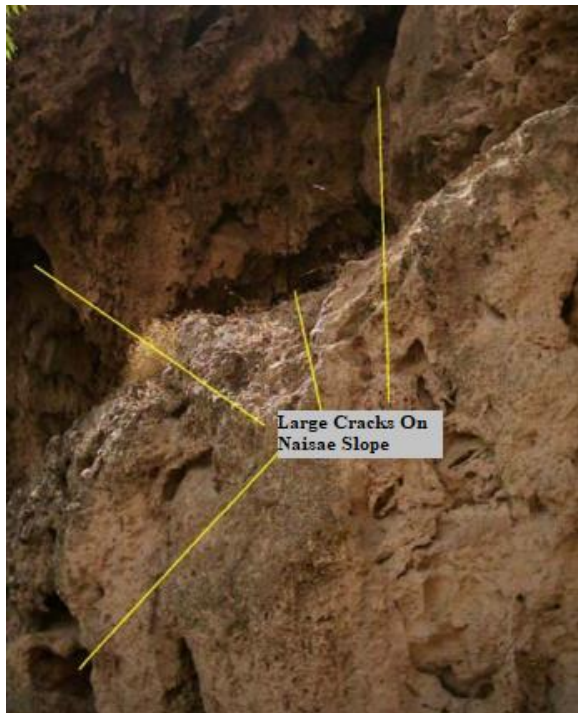
**Fig. 4.** Development of new cracks and voids after a seismic episode

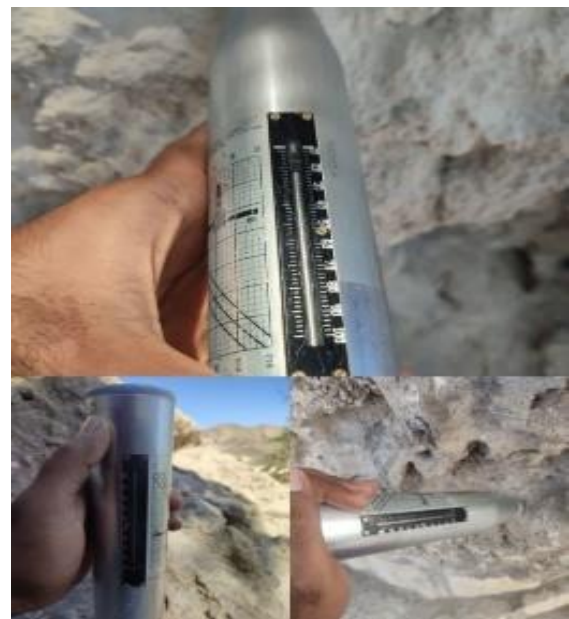
**Fig. 5.** Schmidt Hammer test

The rock strength was evaluated using a Schmidt hammer. Tests were performed at multiple locations around the waterfall, pavilion, and the staircase connecting them. Field observations indicated generally weak rock characteristics throughout most of the tested areas. This weakness is primarily attributed to the presence of marl and gypsum interspersed with limestone and travertine within the rock mass. Schmidt

hammer rebound values ranged from 10 to 15, indicating low rock strength at nearly all tested sites. Similar low values were recorded inside the cave, further confirming the overall rock weakness. These findings classify the rock in the study area as a weak rock type, likely due to its mineralogical composition.

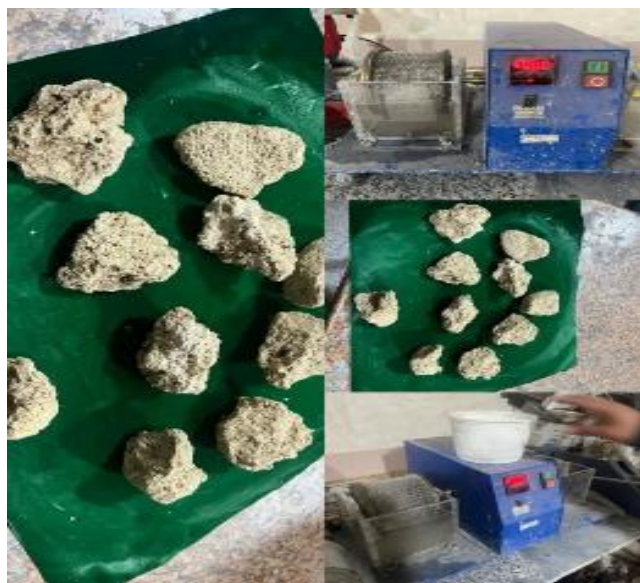
**Fig. 6.** Slake Durability test for rock

Total weight of 10 rock pieces' oven dried  $W_1 = 274$  grams

Total weight of 10 rock pieces after 2 cycles and oven dried  $W_2 = 178$  grams

$$SDI = W_2/W_1 * 100 = 178/274 * 100 = 64.9\%$$

Based on the Standard Test Index, the rock is classified as having medium durability.
